FLIGHT MEASUREMENTS OF LATERAL AND DIRECTIONAL  
STABILITY AND CONTROL CHARACTERISTICS  
OF THE GRUMMAN F8F-1 AIRPLANE

TED NO. NACA 2379

H. L. Crane and J. P. Reeder

Langley Memorial Aeronautical Laboratory  
Langley Field, Va.

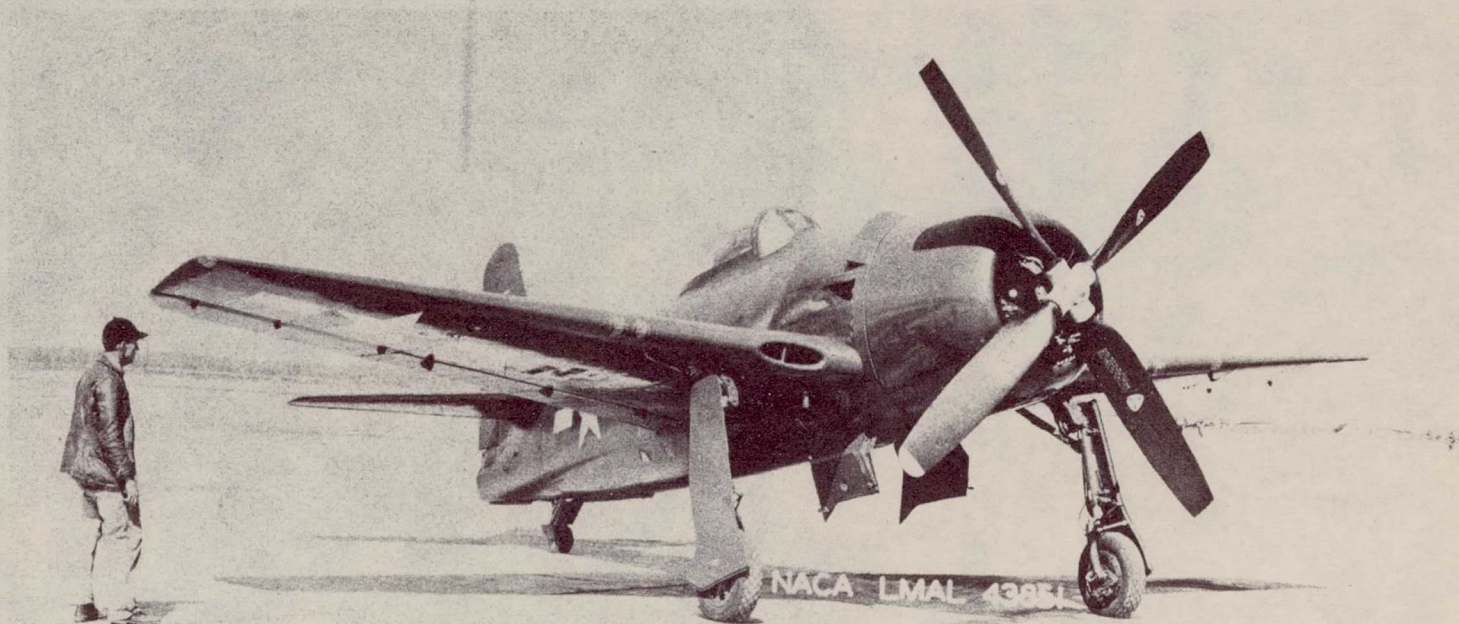
(a) Without belly tank.

Figure 1.- Three-quarter front view of Grumman XF8F-1 airplane.

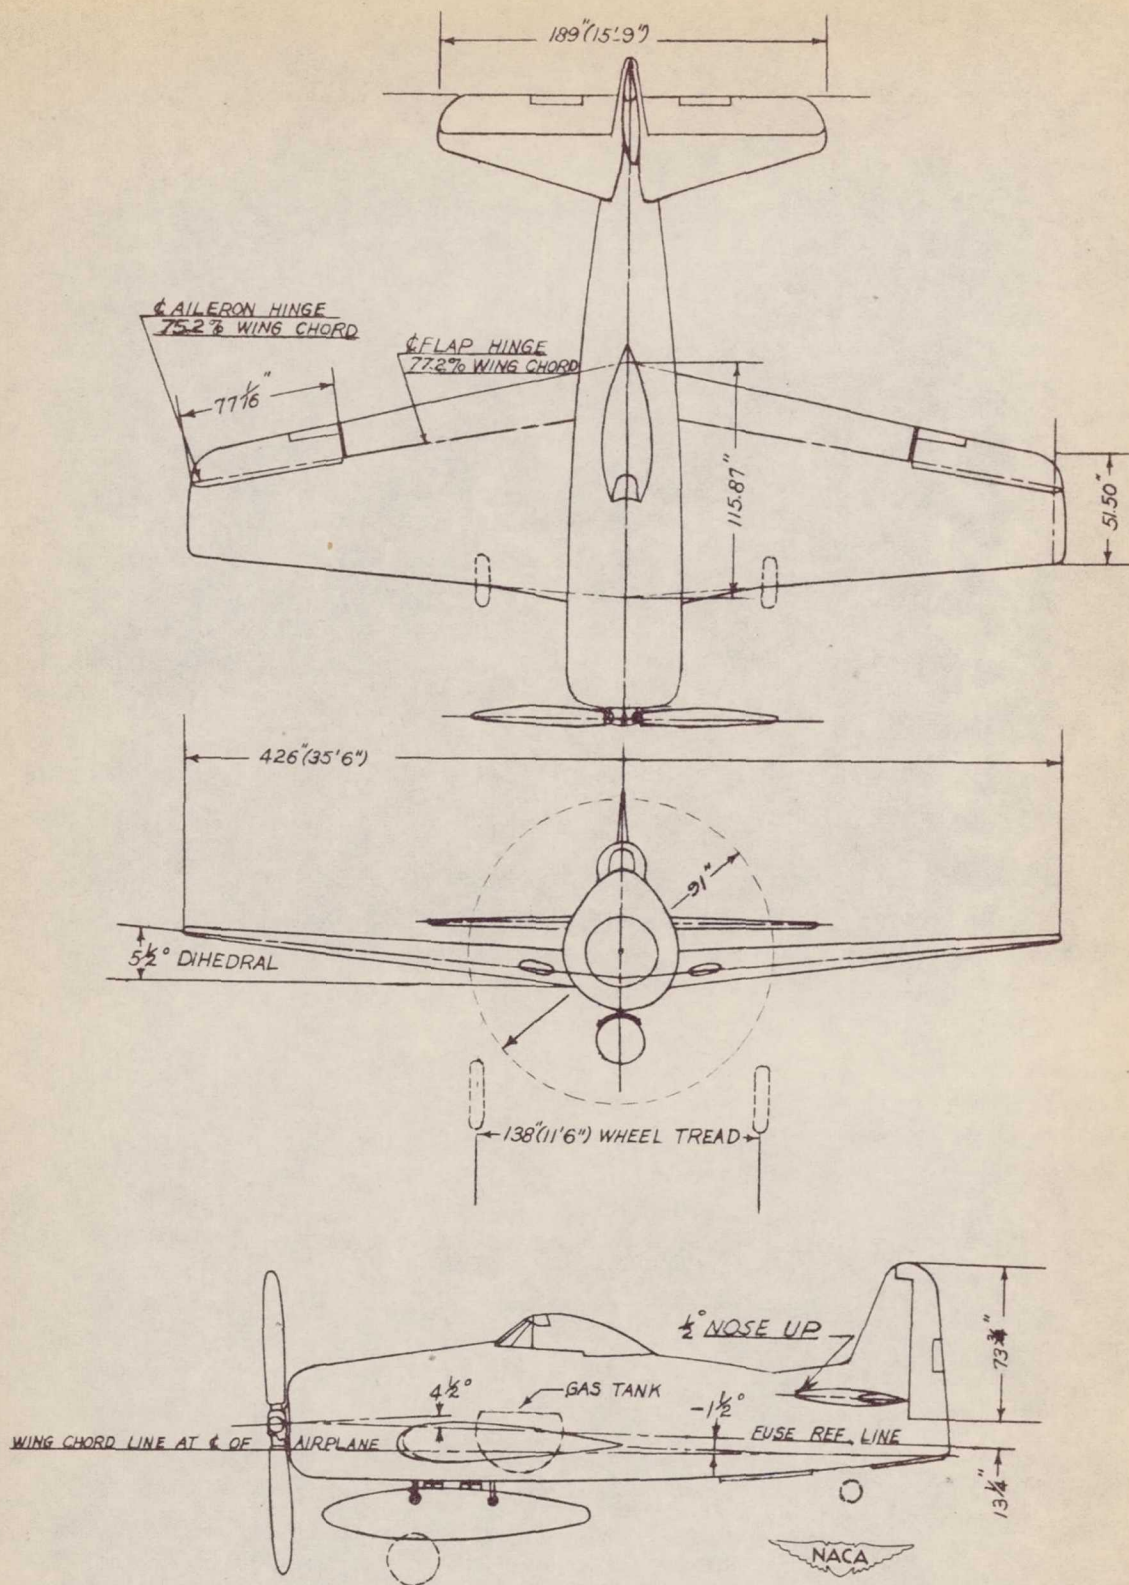
(a) Three-view drawing with tail configuration number 1.

Figure 2.- Drawings of F8F-1 airplane.

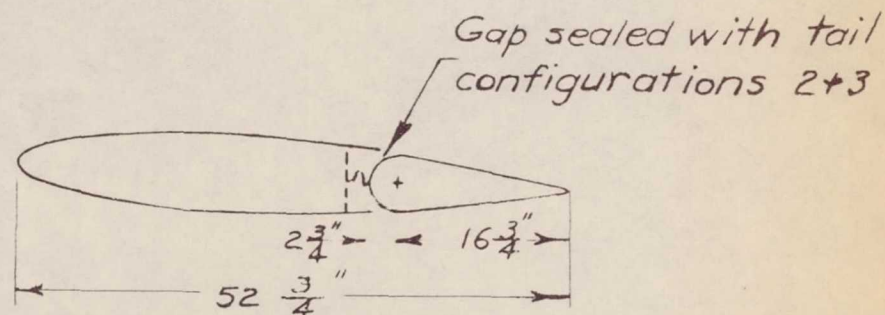
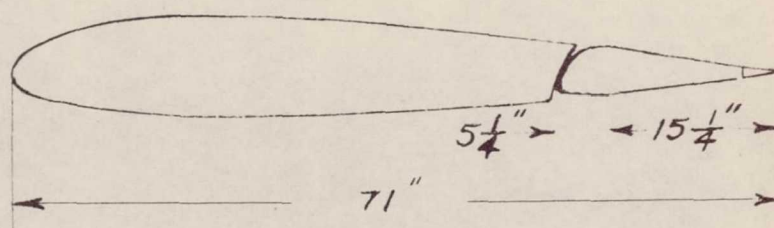
Vertical tail, 21 inches above fuselage reference line

Horizontal tail, 15 inches from center line

Wing and aileron, 64 inches from tip.

(b) Section views through aerodynamic surfaces of F8F-1 airplane.

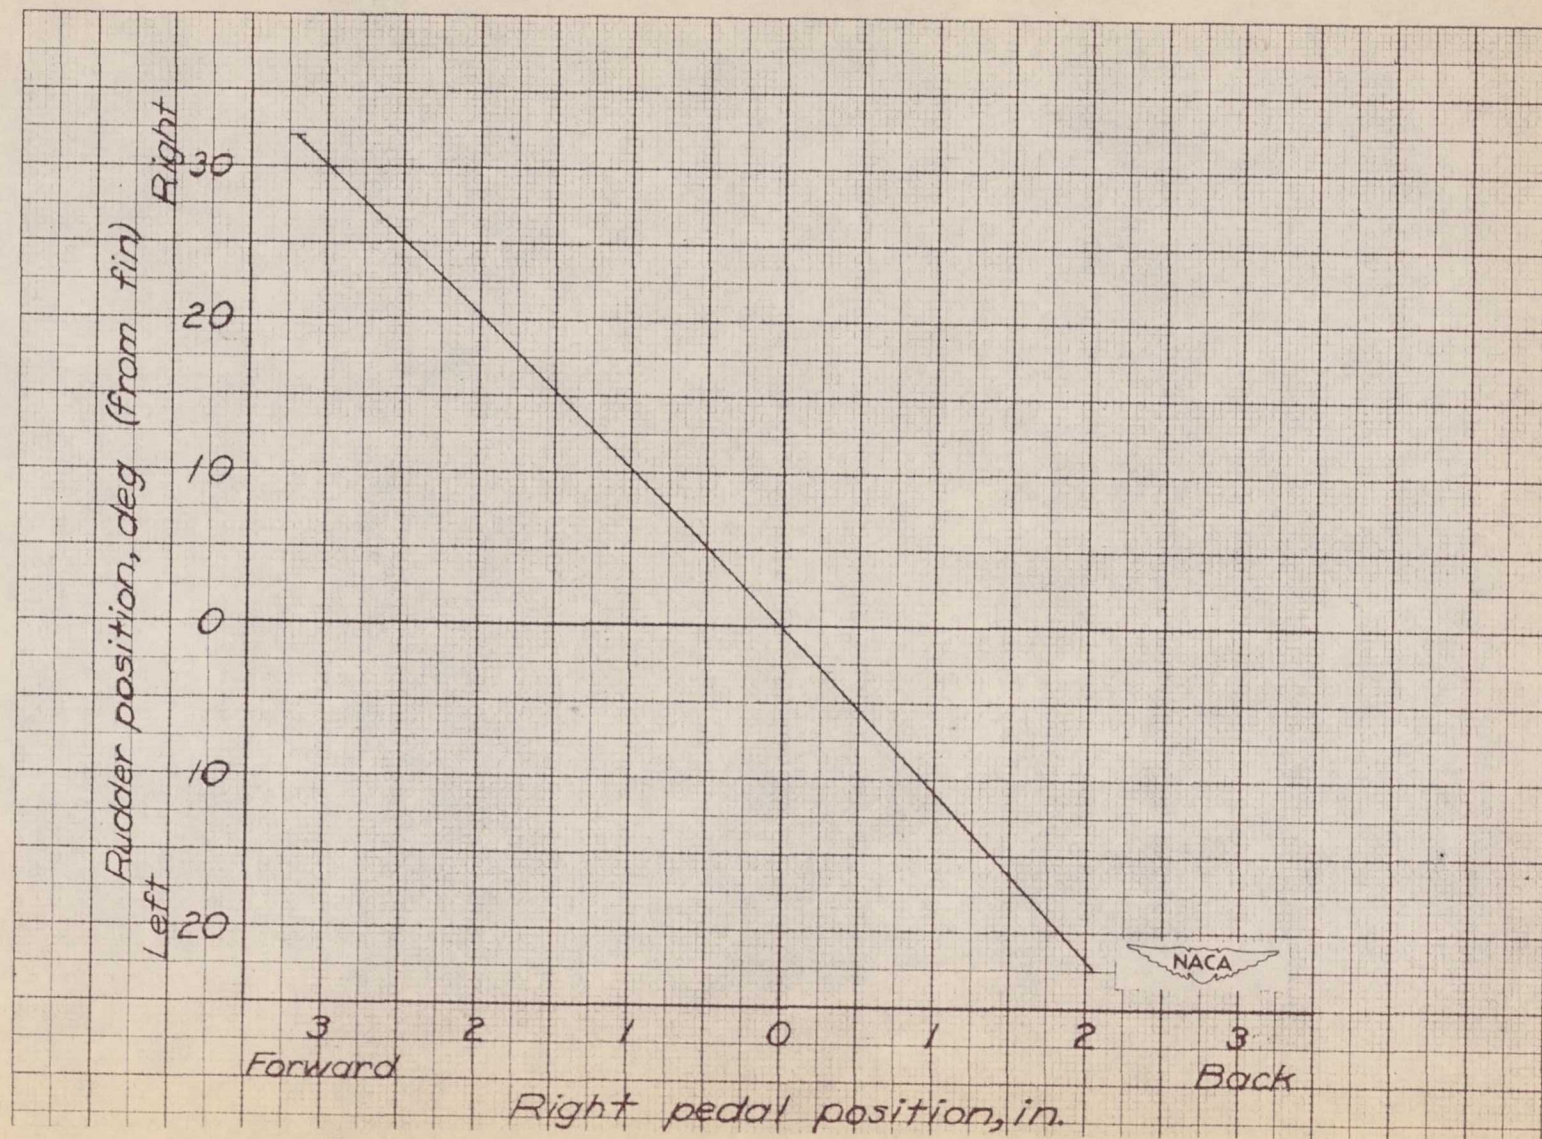
Figure 3.- Linkage between rudder and rudder pedal, F8F-1 airplane.

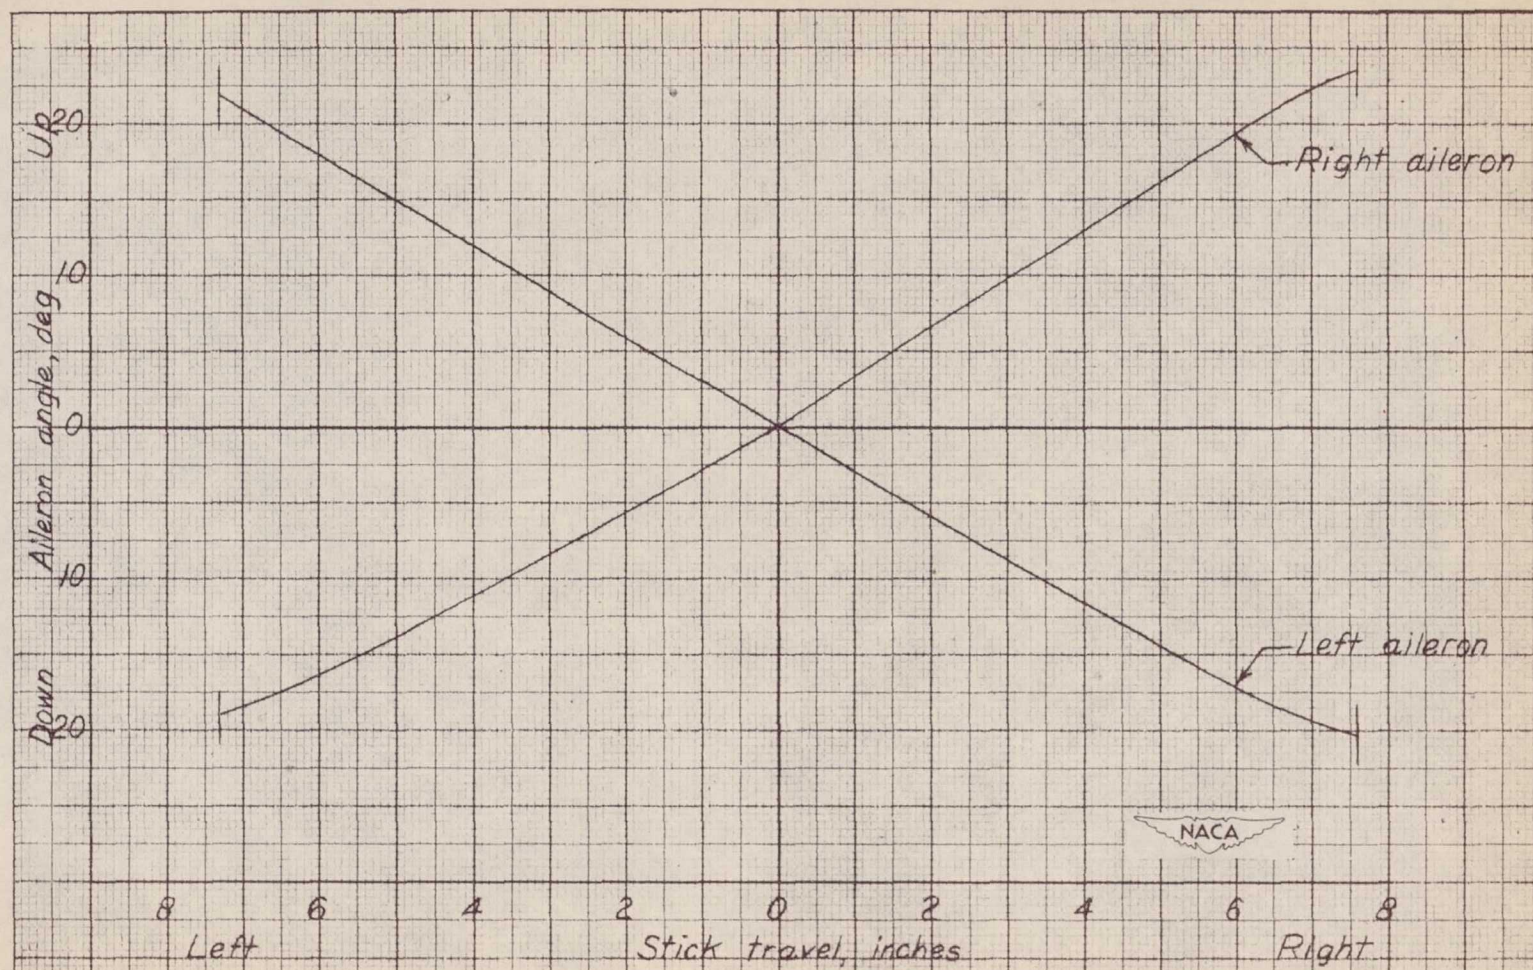
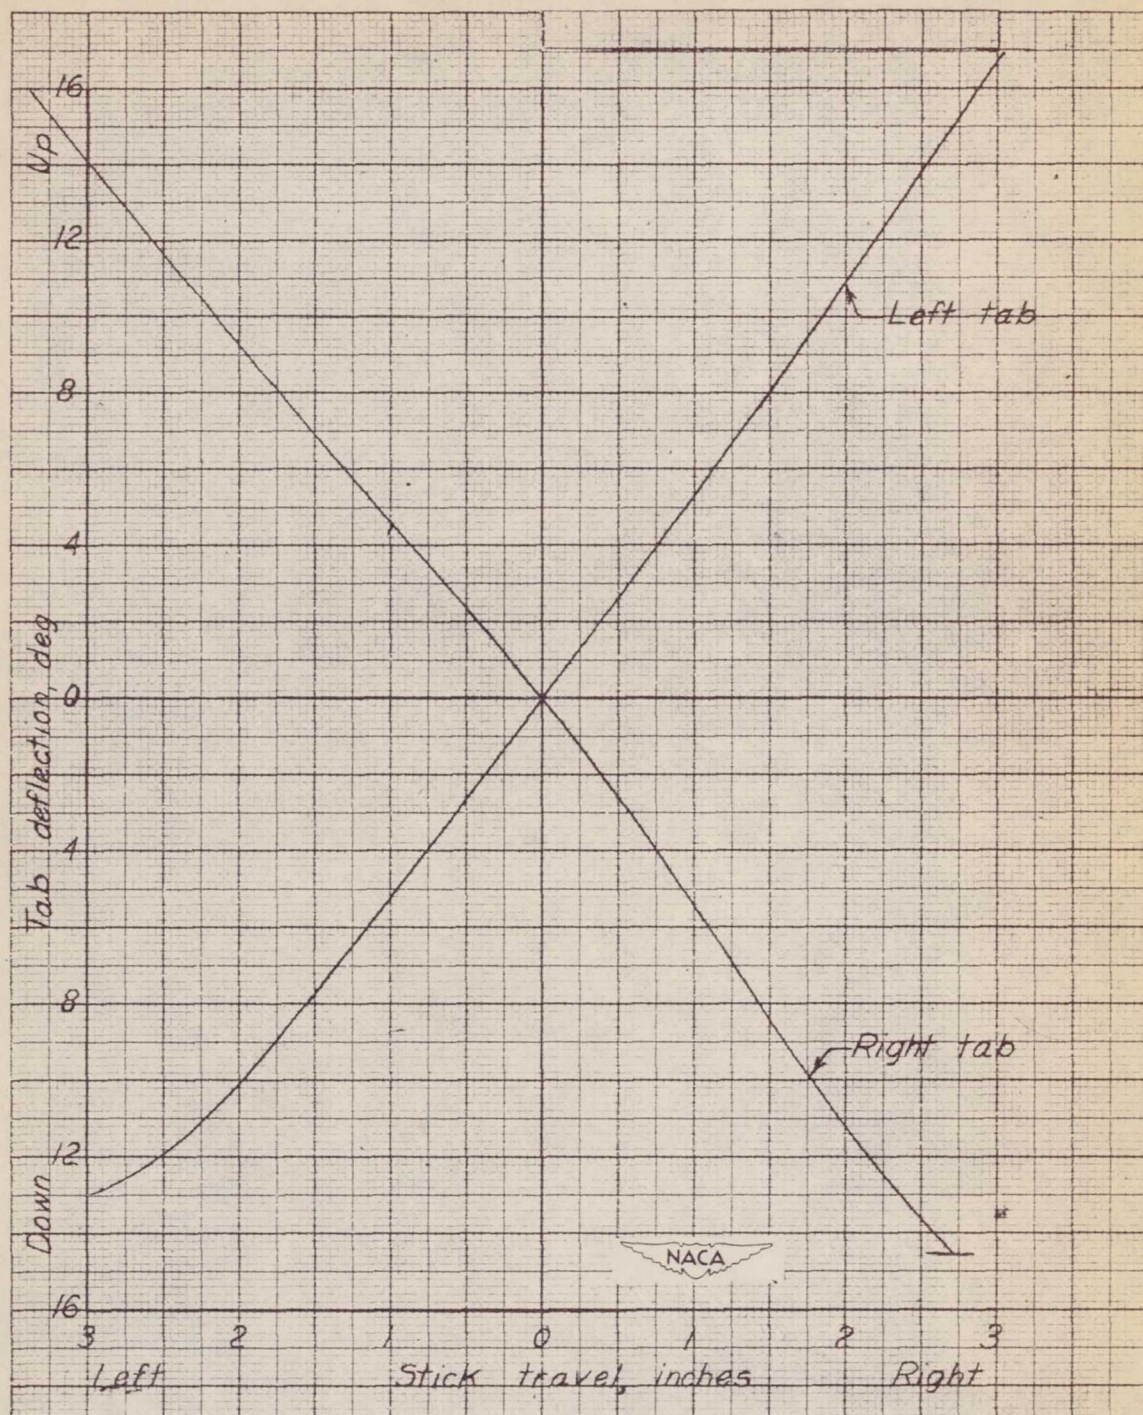
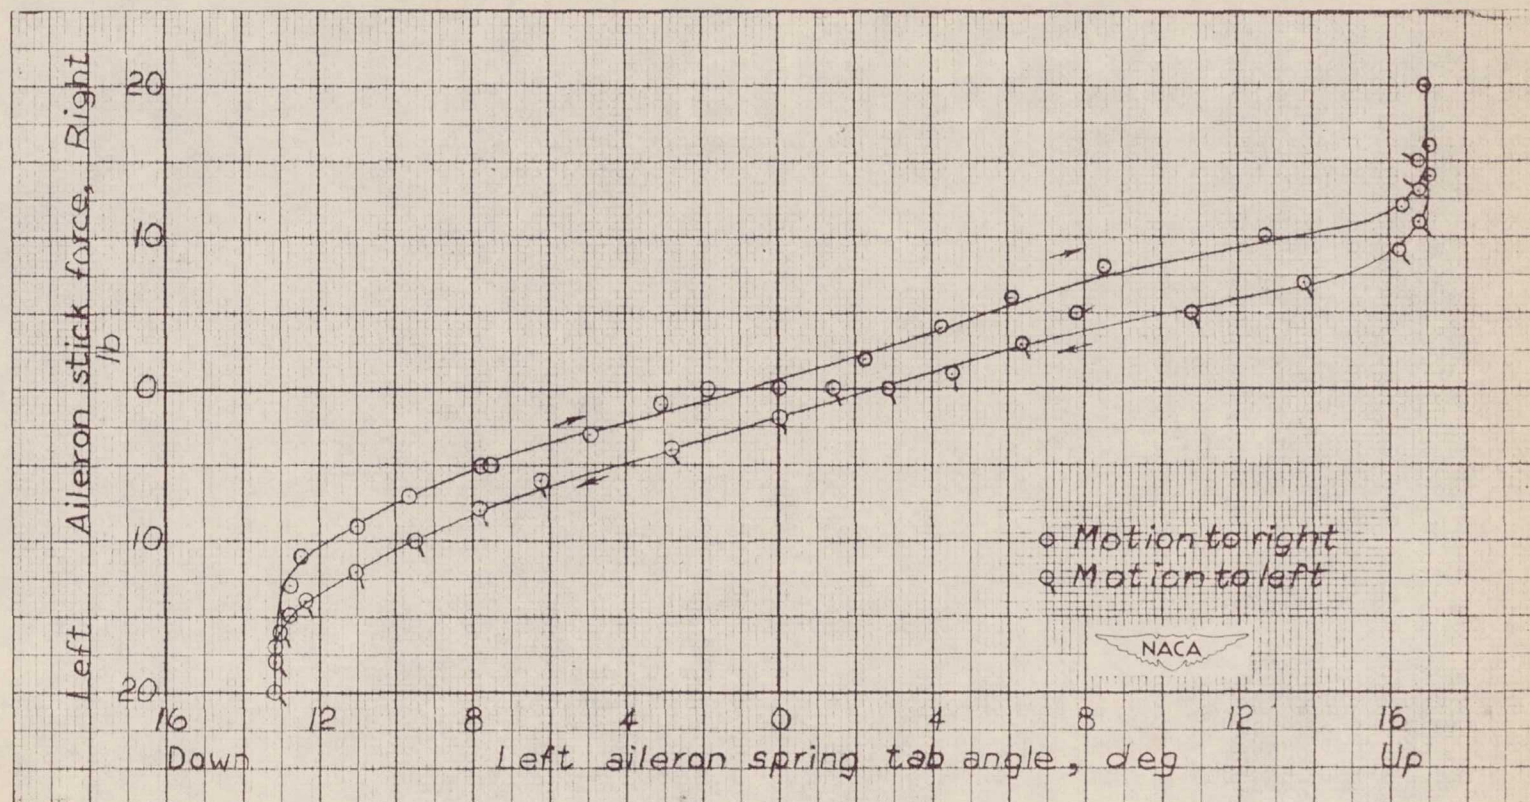
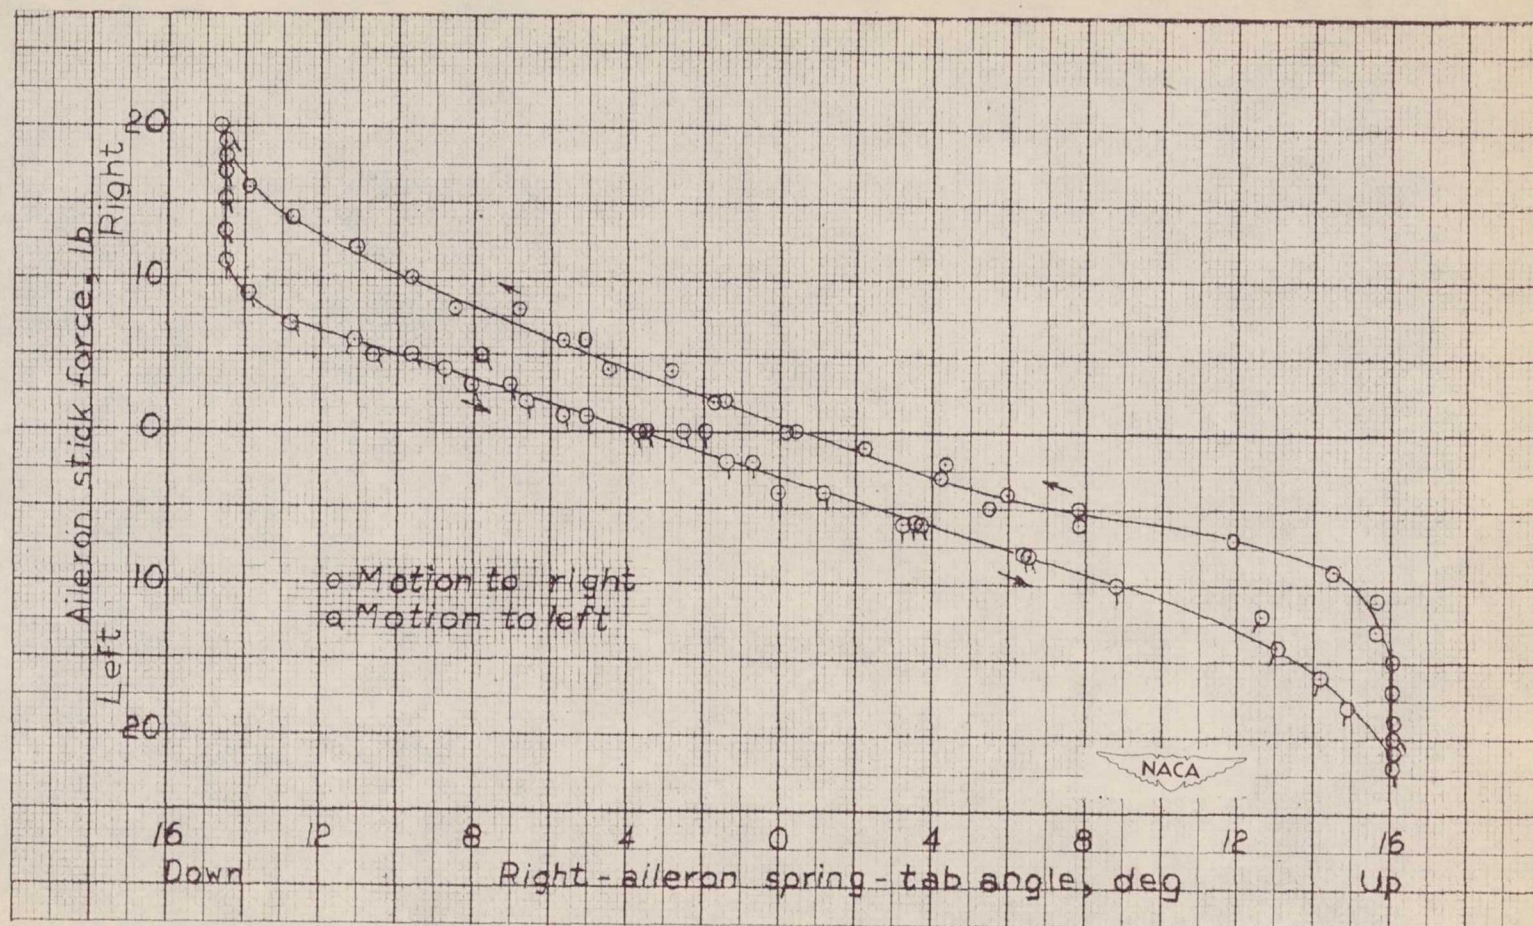
(a) Variation of aileron deflection with stick position  
(no aerodynamic load).

Figure 4.- Characteristics of the aileron control system of an F8F-1  
airplane (Bu. Aero. No. 90461).

(b) Variation of aileron-spring-tab deflection with stick position with ailerons locked.

(c) Variation of left aileron-spring-tab deflection with stick force with left aileron fixed.

(d) Variation of right aileron-spring-tab deflection with stick force with right aileron fixed.

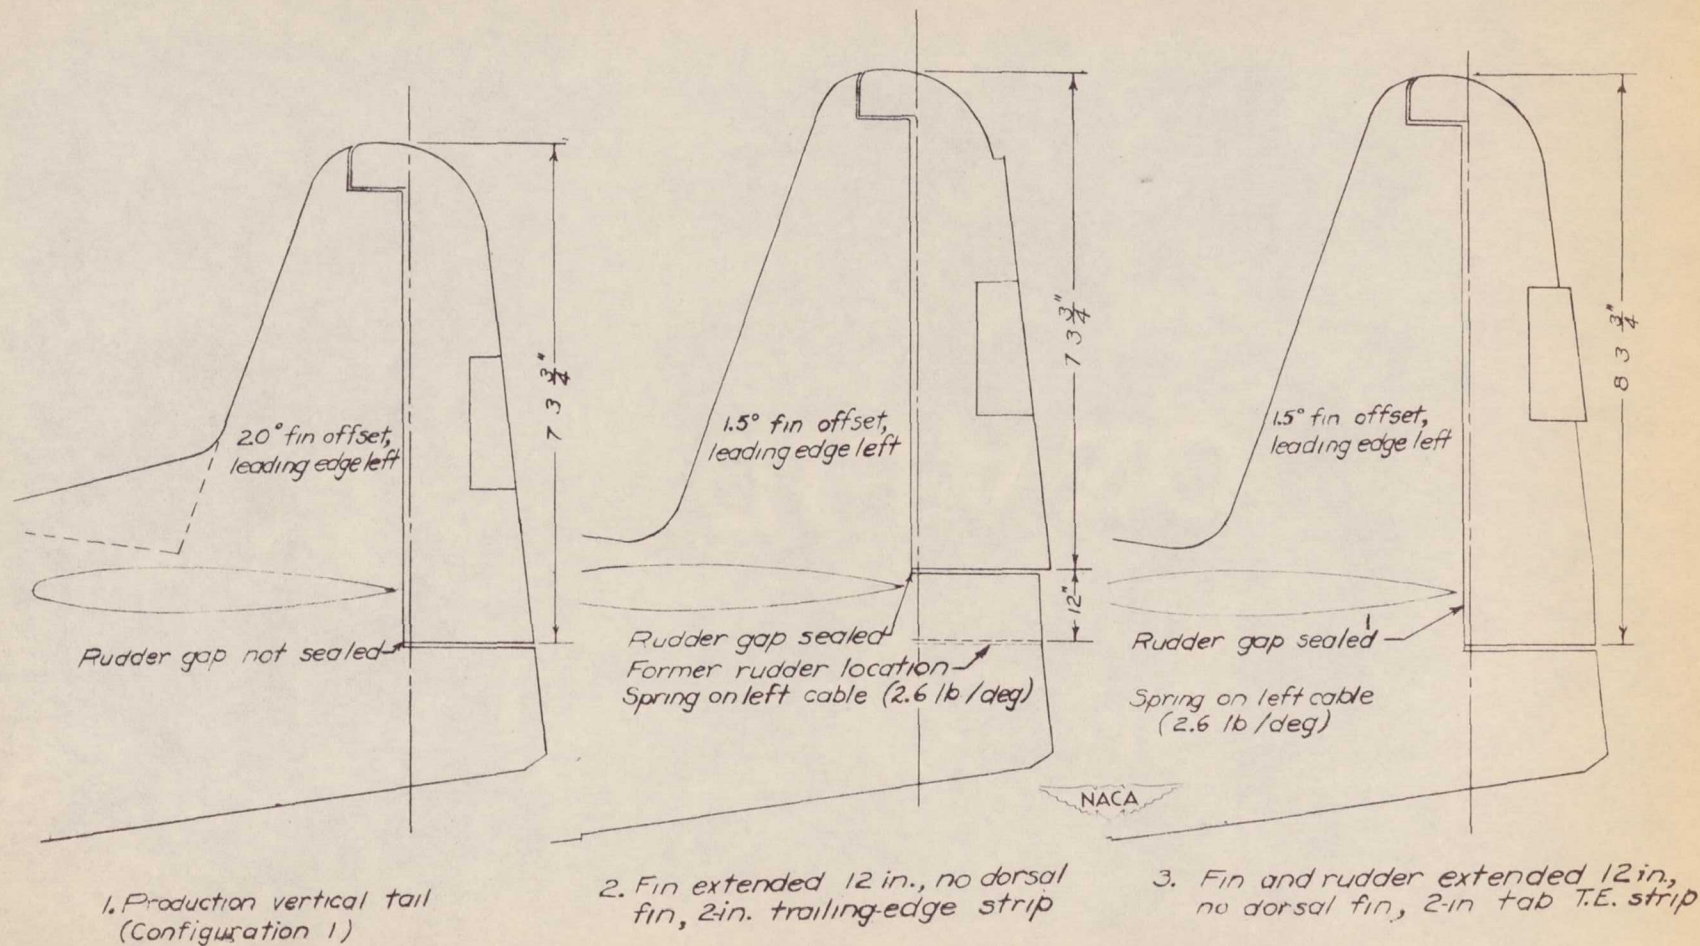
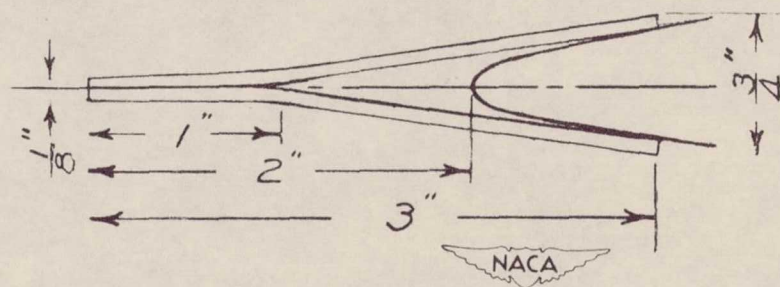
(a) Plan view.

Figure 5.- Sketches of the three tail configurations.

(b) Sketch of rudder trailing-edge extension used on tail configuration 2.

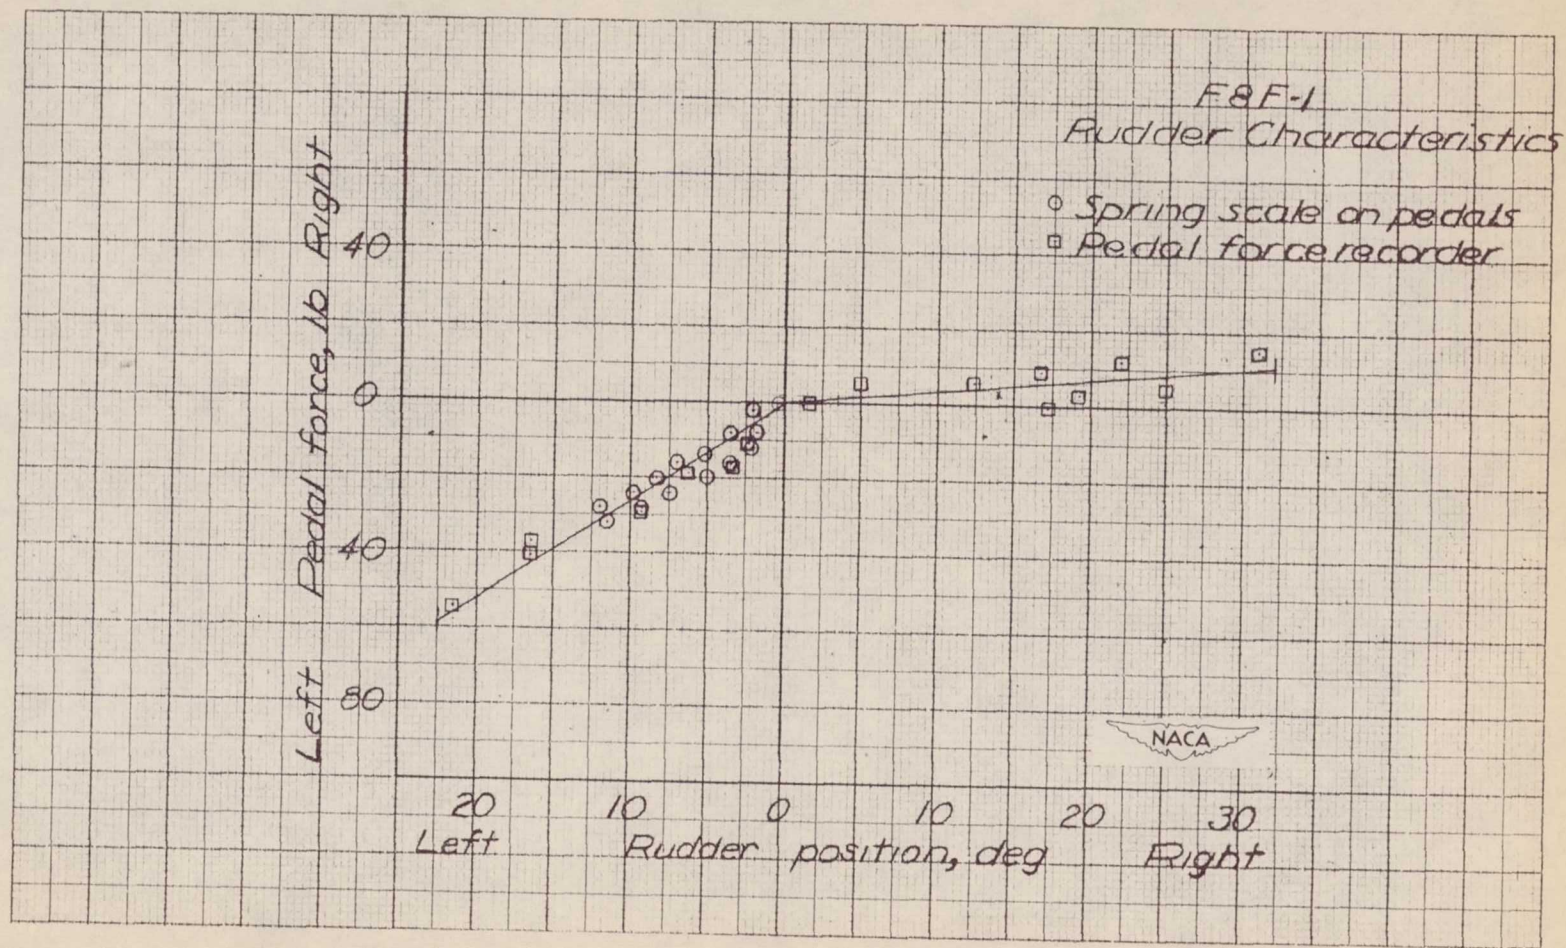
Figure 6.- Variation of rudder pedal force with rudder position, F8F-1 airplane (BuAero No. 94873) with spring on left rudder cable.

In right sideslips of about  $15^\circ$ , there was a tendency toward rudder overbalance with tail configurations 2 and 3 at low speeds. This tendency was counteracted somewhat by the spring in the left rudder cable so that no overbalance occurred in the range of angles of sideslip covered by the data presented in figures 25 and 26. However, a small amount of rudder overbalance has been measured with tail configuration 3 when there was a small yawing velocity at angles of sideslip from  $20^\circ$  to  $35^\circ$  right in the power-approach condition at low speeds. A time history of such data is presented in figure 27. The tendency toward rudder-force reversal was hardly noticeable with tail configuration 1 which had a dorsal fin. It is believed that retention of the original dorsal fin on tail configurations 2 and 3 would have greatly reduced the tendency toward rudder-force reversal.

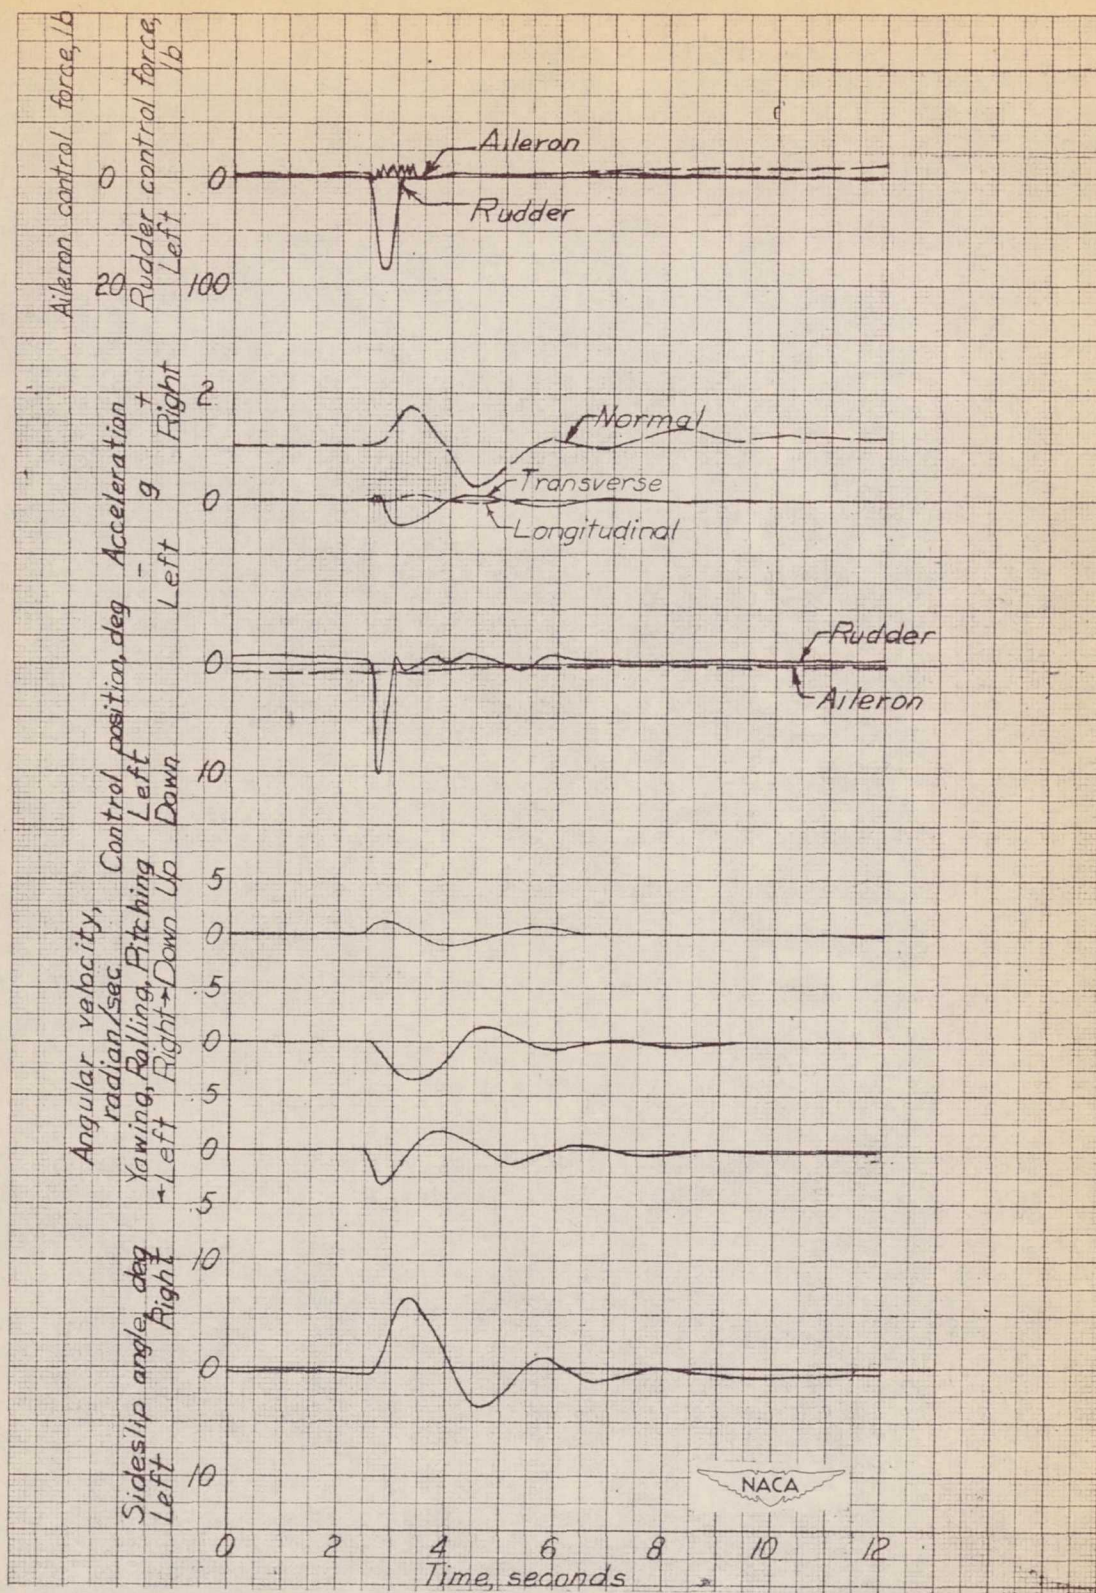
Figure 7.- Oscillations of F8F-1 airplane in the clean condition with power for level flight at 290 miles per hour at an altitude of 5000 feet, caused by a left rudder kick and release. (Tail configuration 1, belly tank off.)

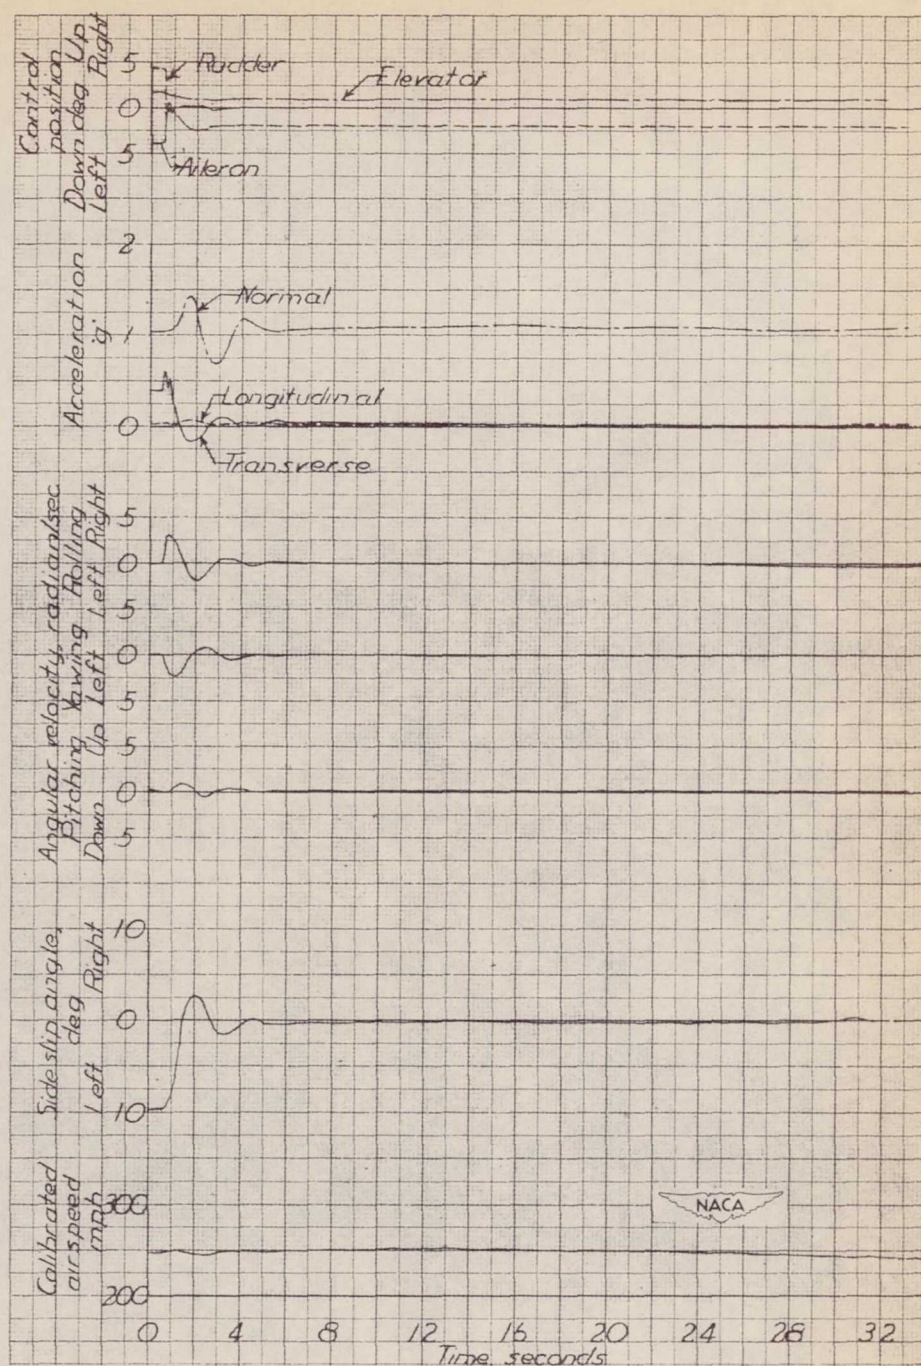
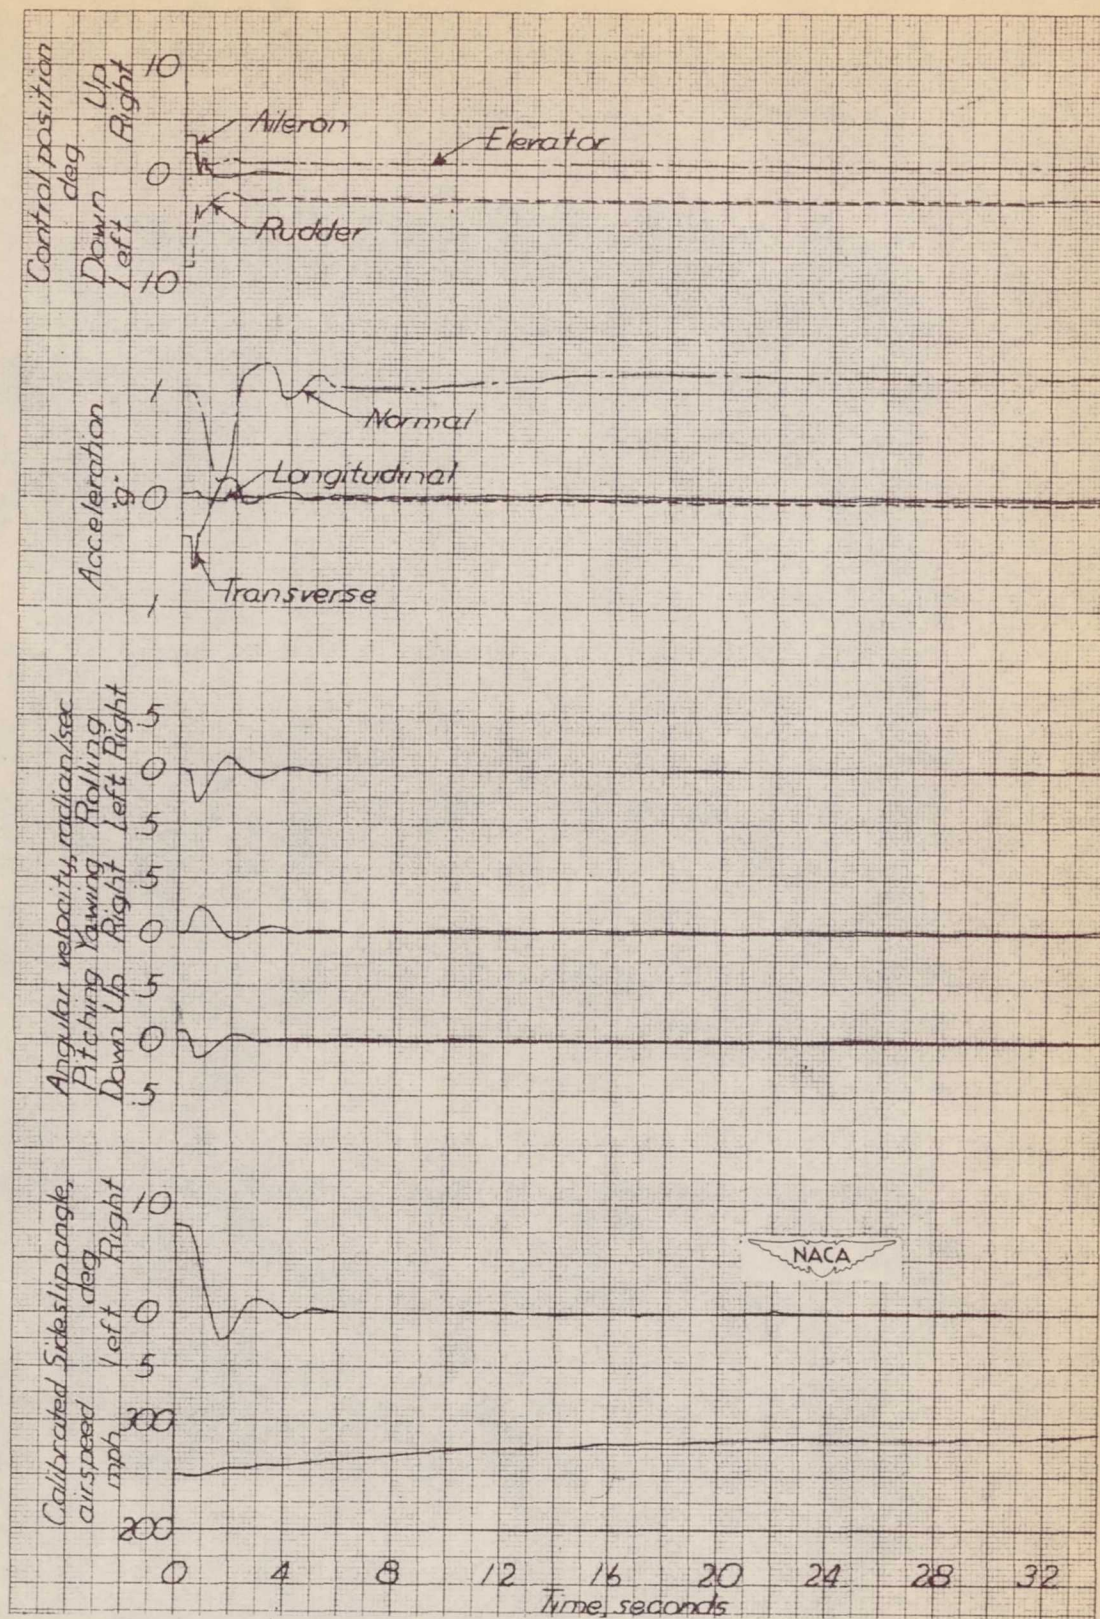
(a) From left sideslip.

Figure 8.- Oscillations of F8F-1 airplane in the clean condition with power for level flight at 250 miles per hour at an altitude of 5000 feet caused by releasing the controls in steady sideslips. (Tail configuration 3 with belly tank on.)

(b) From right sideslip.

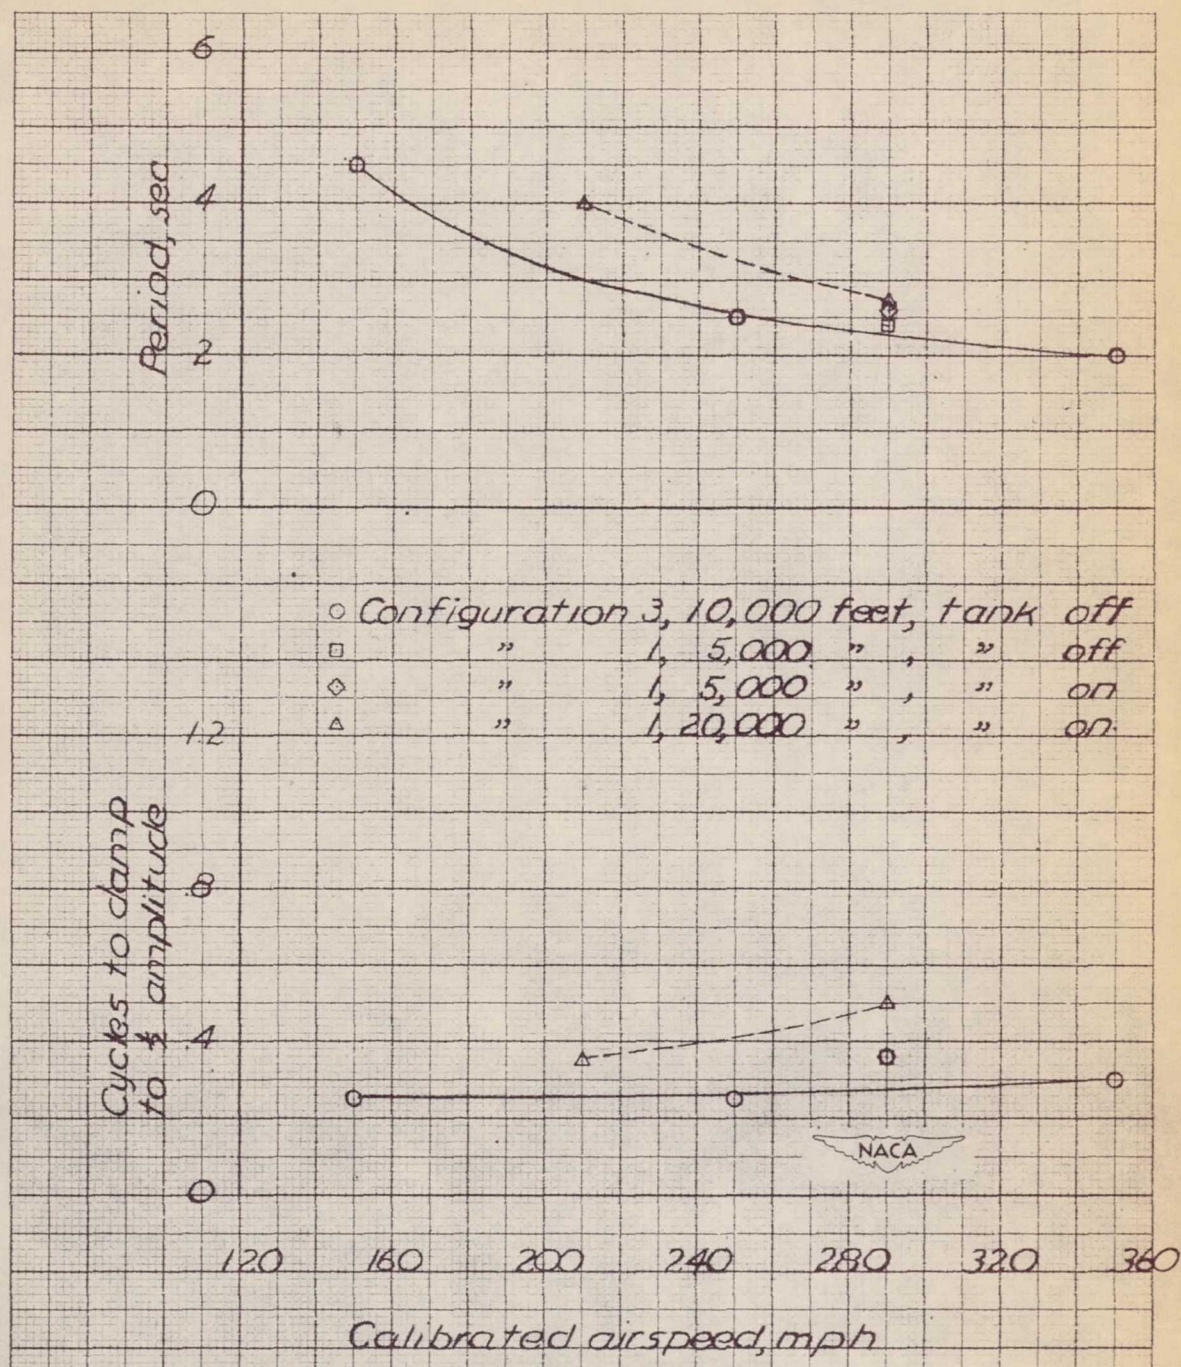
Figure 9.- Variation with speed of the period and rate of damping of lateral oscillations in the clean condition with power for level flight, F8F-1 airplane.

Control-free lateral oscillations were made to determine the effect of speed, altitude, of the belly tank, and vertical-tail configuration. These tests were made in the clean condition with power for level flight either by abrupt deflection and freeing of the rudder or by releasing the controls in steady sideslips. Figures 7 and 8 present time histories of typical oscillations of each type. Summary plots which show the period of the lateral oscillations and the number of cycles required to damp to one-half amplitude as a function of speed are shown in figure 9.
